Manhole Inspection Summary

Manhole # S41Y1_018MH

Insp Date: **12/12/07 12:20 PM**

Location Address: **815 E. Patapsco** Cross Street: **between 8th & 9th st**

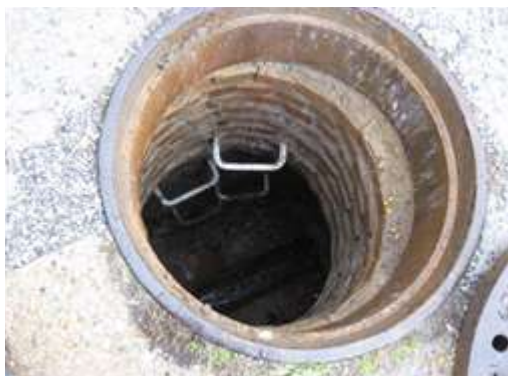
Steps Count: **4** Missing: **0** ☒ **Corroded**

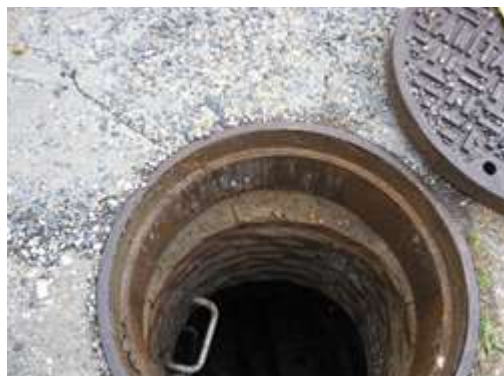
Defect 1

Frame Offset: **3** (in.) Condition: ☒ Sound ☐ Cracked ☐ Leaks

Chimney offset

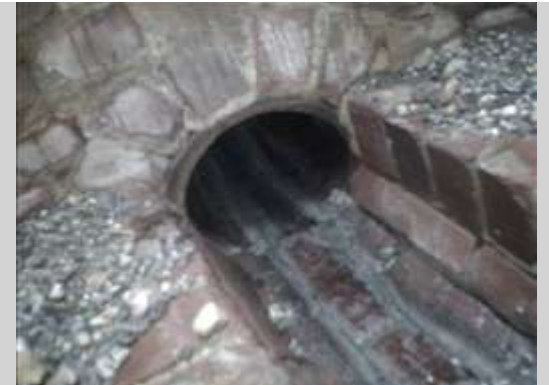
12 O'Clock Outflow

8 in. Circular Gravity Sewer
Pipe Out @ 12 O'Clock

Pipe Height: **10.8** (in.) Rod and Bar (Angled)
Pipe Material: **Clay** ☐ Pipe Lined
Invert Depth: **8.82** (ft.) Flow Characteristics: **Fast**
Deposits: ☐ None ☐ **Mud** ☒ **Sludge** ☐ Debris ☐ Grease
Silt Depth: **1** (in.) Deposits Extent: **Light**
Infiltration: **None** Pipe Seal Cond: **Sound**

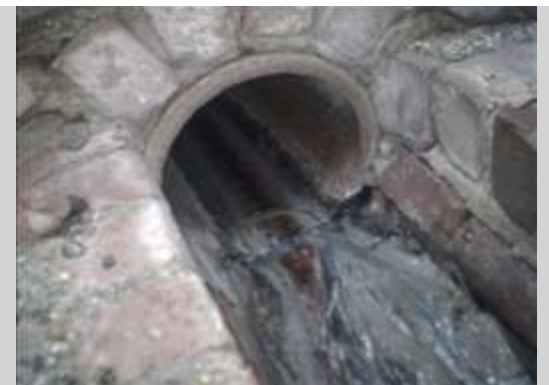
6 O'Clock Inflow

8 in. Circular Gravity Sewer
Pipe In @ 6 O'Clock

Pipe Height: **10.8** (in.) Rod and Bar (Angled)
Pipe Material: **Clay** ☐ Pipe Lined
Invert Depth: **8.52** (ft.) Flow Characteristics: **Fast**
Deposits: ☐ None ☒ **Mud** ☒ **Sludge** ☐ Debris ☐ Grease
Silt Depth: **1** (in.) Deposits Extent: **Light**
Infiltration: **None** Pipe Seal Cond: **Sound**
